Digital Recovery Sequencer

(UDRI)

Materials & Manufacturing Directorate

3 Aug 2020

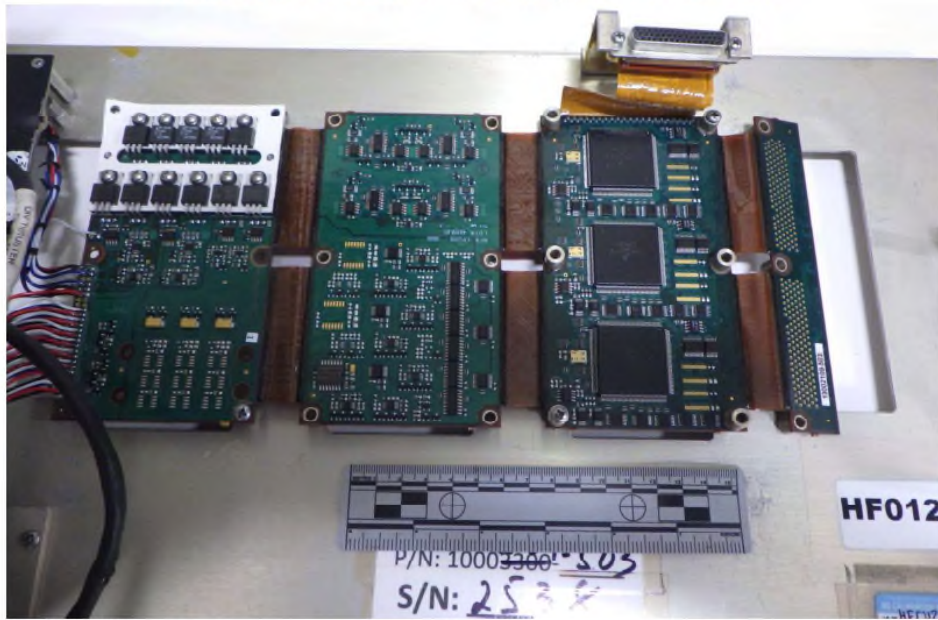
Incident PWB from DRS, As-Received

- Overall workmanship was considered good.
- PWB and components were generally clean.
- Solder junctions were well formed. No cracks observed.
- Conformal coating was somewhat uneven, but coverage appeared adequate.
- No evidence of delamination, corrosion, tin whiskers, dendrites, arcing, or thermal damage.

- Five surface mount devices (SMDs) did not have conformal coating, and had evidence they were recently replaced:
 - Serial flash memory chips U58, U76, and U94
 - Parallel flash memory chip U73
 - Dual axis accelerometer U41
- SMD capacitor C262 was partially dislodged from solder pads.

- Some components were suspected of being counterfeit. More analysis is needed.

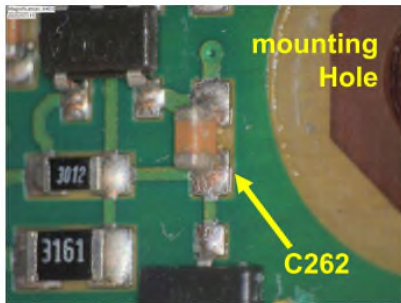
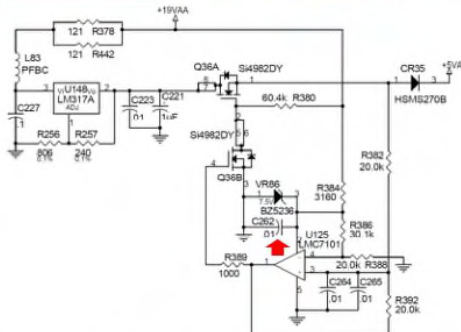
Capacitor C262

- 0.01 μF ceramic SMD capacitor.
- Function: bypass/decoupling capacitor for op amp U125's 7.5 V power supply terminals.
- Partially dislodged from solder pads.
- Each capacitor terminal is making electrical contact with its respective pad.
- Direct, localized impact the most likely cause. (No other components had a similar failure.) Hypothesis: since C262 is adjacent to mounting hole, it was damaged during installation or removal of PWB by accidental direct contact with mounting hardware.

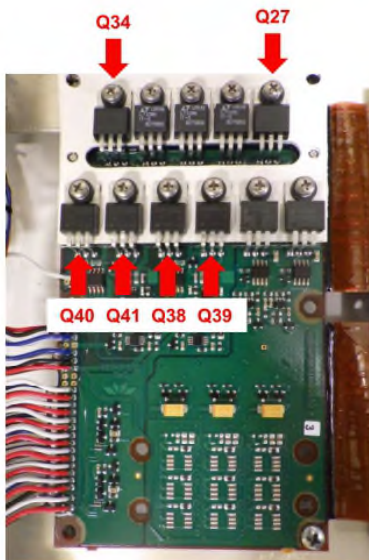
Power MOSFETs – Suspect Counterfeit Components

- Siliconix SUB75N08-10.
- TO-220 package.
- Quantity = 6.
- No conformal coating.
- **Obsolete.**
- Function: series element switches used in 19 V regulator circuits and BUSA/B (power supplies for firing EEDs).
- **Suspected of being counterfeit. More analysis needed.**

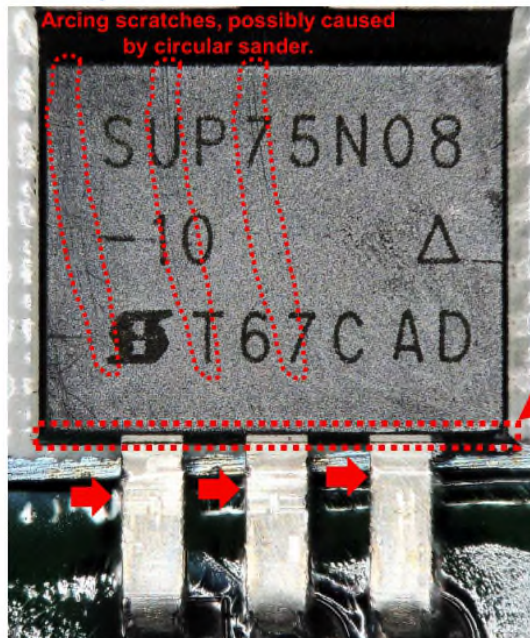
Example: Power MOSFET Q27

Font and Style of markings match those of genuine components

Top of leads have deep horizontal grooves, possibly caused by a clamp. Other TO-220 devices on PWB do not exhibit these grooves.

This corner (and only this corner) is heavily gouged, possibly caused by a sander.

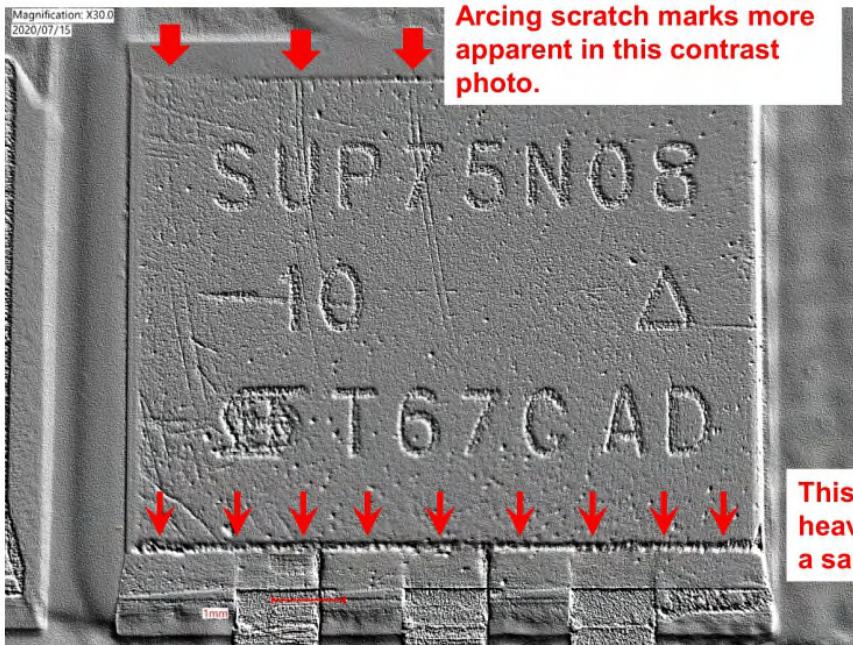
Power MOSFET Q27 cont.

Arcing scratch marks more apparent in this contrast photo.

This corner (and only this corner) is heavily gouged, possibly caused by a sander.

Better photos and analysis can be performed after components are removed from PWB.

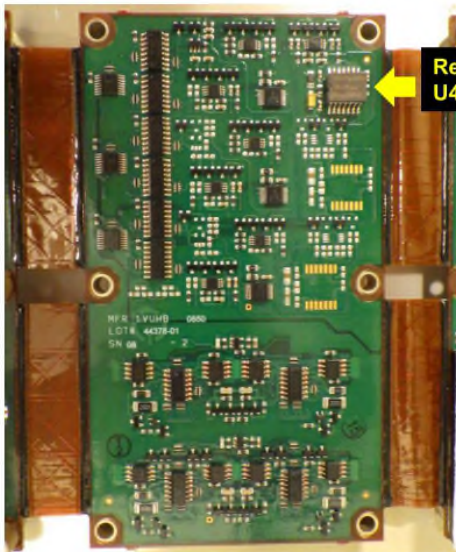
Dual Axis Accelerometers – Suspect Counterfeit Components

- Analog Devices ADXL250AQC.
- 14 lead Cerpac package.
- Quantity of one on PWB (U41).
- Obsolete.
- AFRL is performing analysis on two ADXL250AQC (U41) chips:

1. Original ADXL250AQC chip mounted on PWB during incident. Removed from PWB by Teledyne after incident. AFRL will refer to this chip as Incident U41.
2. After removal of Incident U41 from PWB, Teledyne installed a replacement on PWB. AFRL will refer to this chip as Replacement U41.

- Both Incident U41 and Replacement U41 are suspected of being counterfeit. More analysis needed.

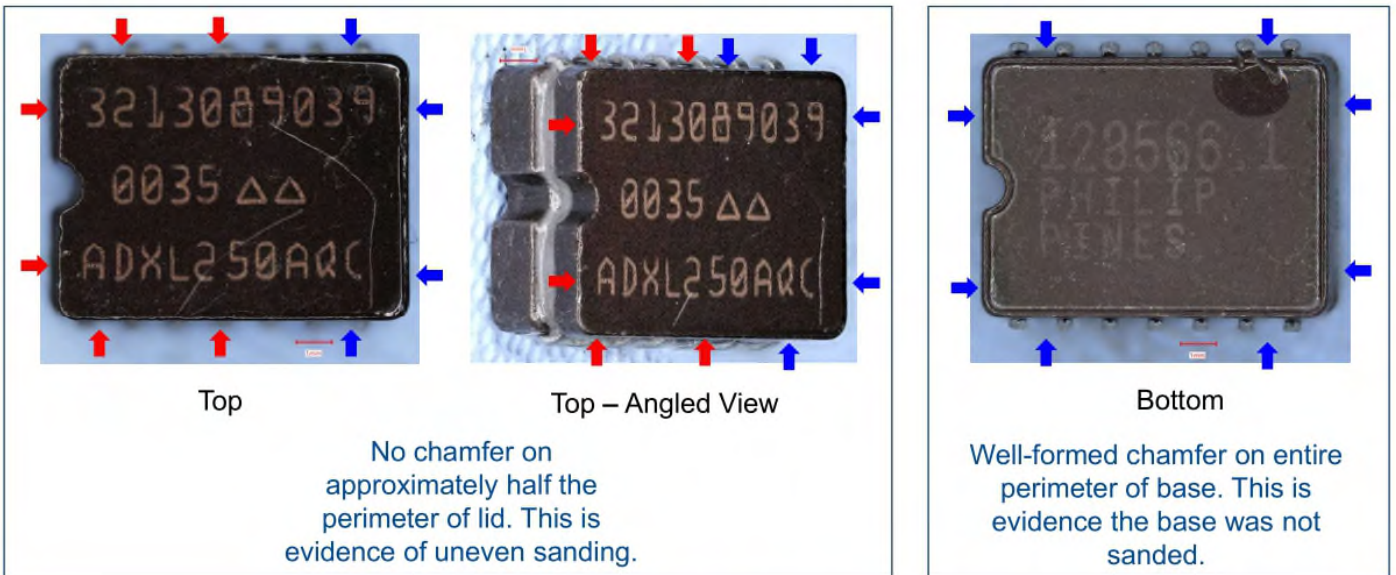
Incident U41 – Suspect Counterfeit Component

↑ = chamfer ↑ = no chamfer

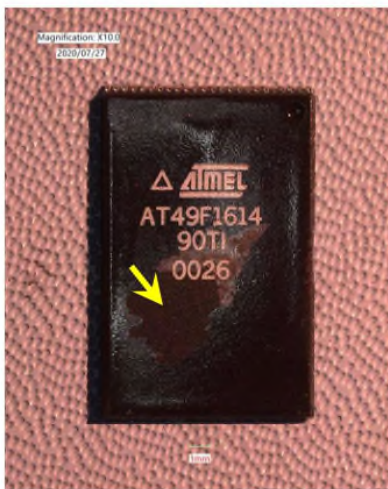
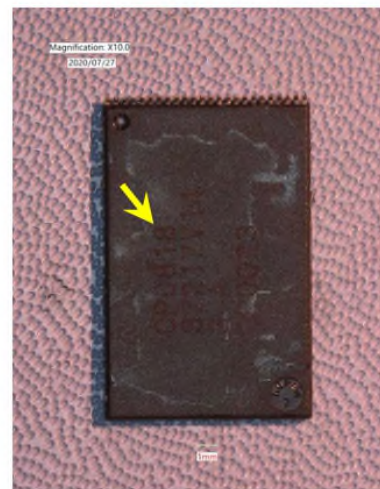
Incident U73 – Suspect Counterfeit Component

Possible "blacktopping" on top side of chip
(conformal coating partially removed. Presumably during
attempted desoldering process)

Laser markings on bottom side of chip

Note: Leads unfortunately were cut to facilitate chip removal from DRS

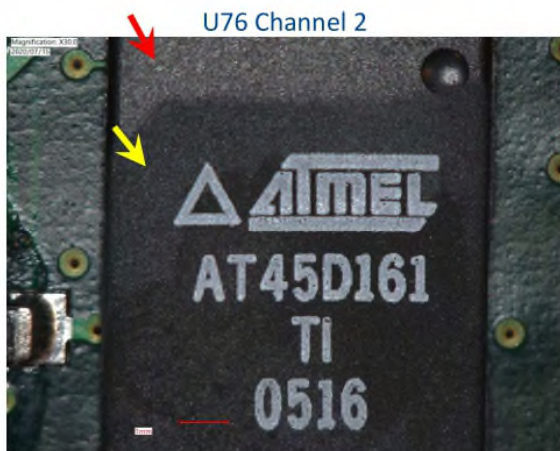
Incident U76 & U94 – Suspect Counterfeit Components

BIG. According to AFRL's forensics analysis, these suspected counterfeit serial flash cards are the 2 channels that failed in the mishap DRS. Channel 1 worked, 2 & 3 failed.

Potential "blacktopping" (yellow arrow) on top side of chip. Normal chip surface (red arrow)

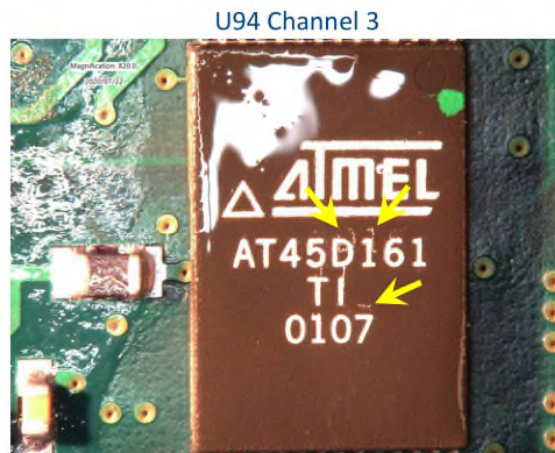
Incident
Serial Flash

Suspect "ghost markings" on top side of chip brought out by application of deionized water. Conformal coating is not present.
